RIO BUENA VISTA WATER AND SEWER SYSTEM
EVALUATION & RECOMMENDATION OF ACTION

APRIL 16, 2025

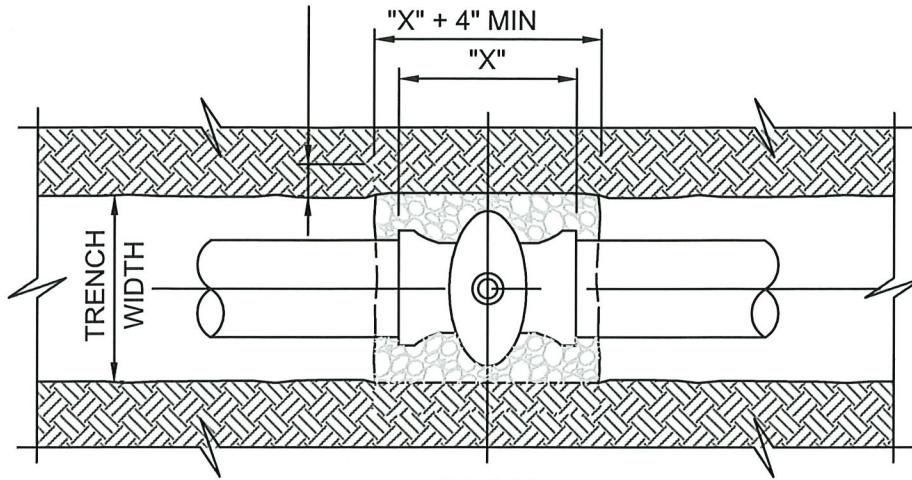
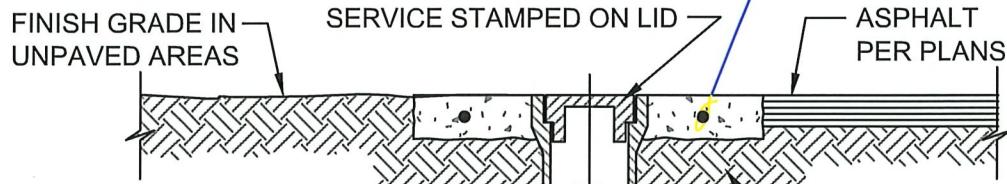
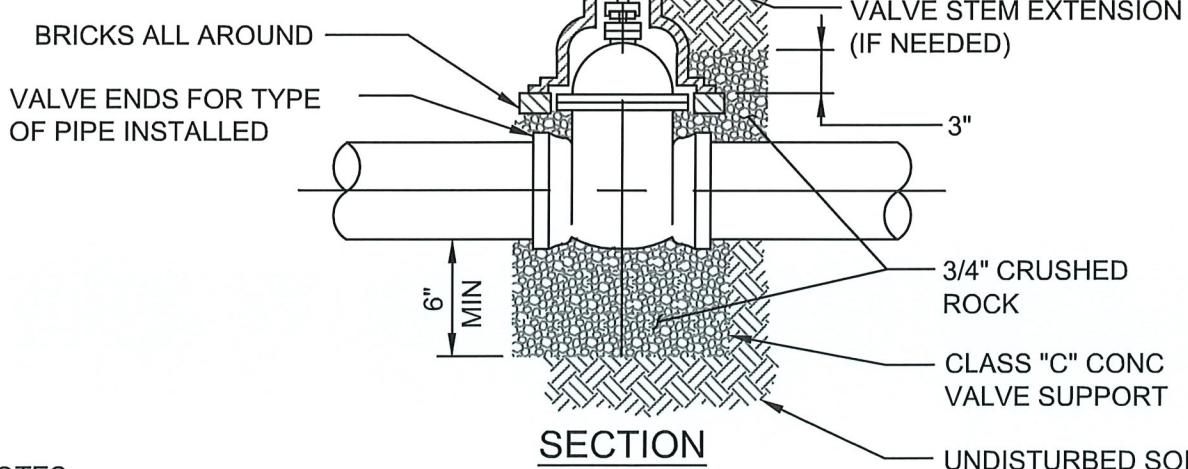
VALVE BOX INSTALLATION

2022 Study: Recommended an additional new isolation valve be installed in Beach Drive near the parking lot in the center of the development.

Action: The Association still need to take this action. Attached is a typical valve installation detail that needs to be used for installation of this valve.

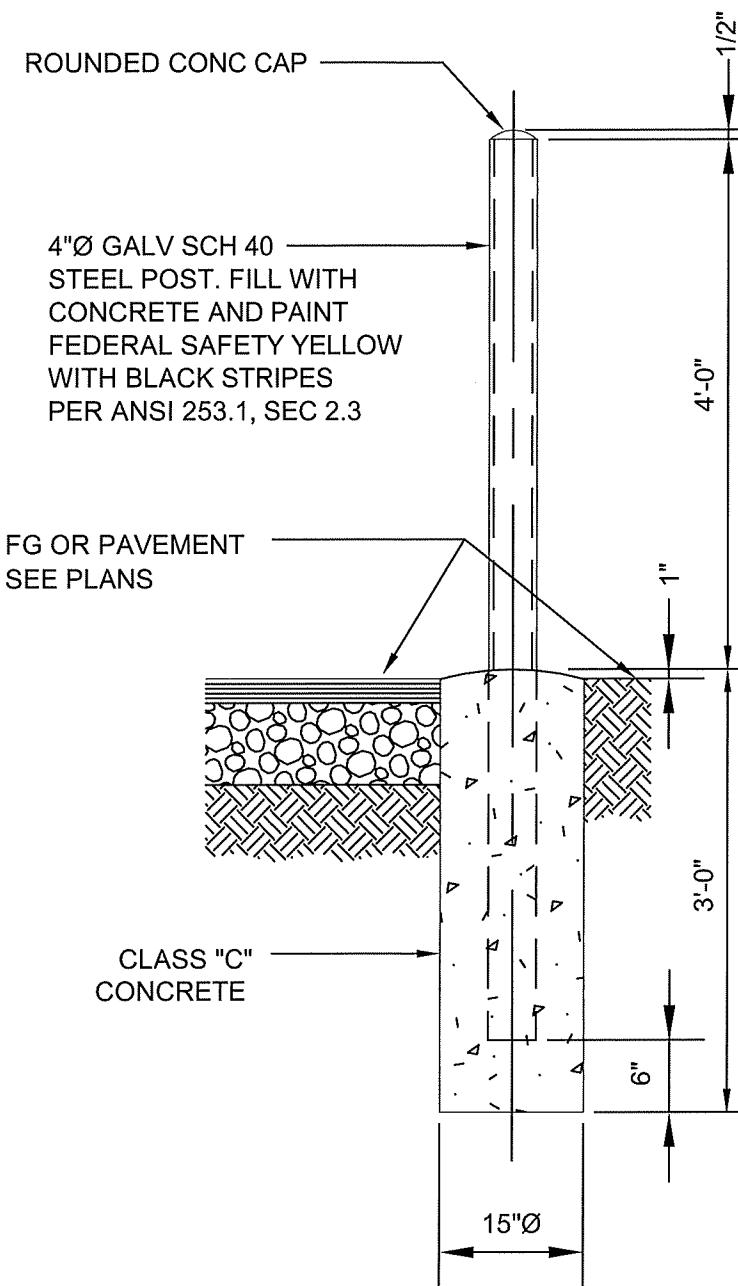
GUARD POST

2022 Study: Recommend installation of (4) pipe bollards, one on each side of the sewer lift station to provide protection against the accidental damage by a vehicle driving over the pump station.

Action: We support the installation of the protective pipe bollards on each side of the lift station. Attached is a detail showing the installation of a typical bollard.
